## dam spillway repairs

<b>Landholder</b>	Suzanne Hopfner and Harry Wolf
<b>Map reference</b>	12
<b>Land use</b>	Land managed for conservation use only
<b>Soil Erosion Solutions Grant</b>	\$5,000 (earthworks, seeds/mulch, hessian, stakes, gabion baskets, geotextile fabric)
<b>Landholder's in-kind contribution</b>	\$6,240 (labour)
<b>Landcare</b>	\$660 (administration)

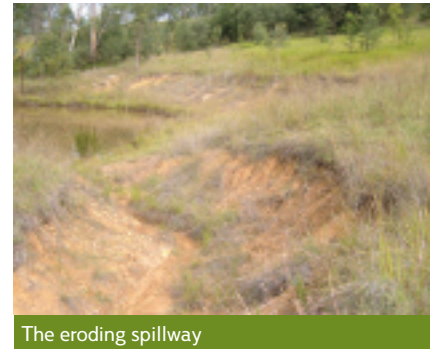
This former grazing property had two severely eroded catch drains leading to a dam with a badly eroded spillway and back batter. The landholder wanted to fix the erosion without getting rid of the dam.

The eroding spillway

- The larger catch drain was filled in.
- Small check structures constructed from hessian secured with wooden stakes were placed across the smaller diversion drain to slow down the water flow and trap some of the sediment.
- The eroded batter on the upslope side of the dam was reshaped.
- The spillway gully was realigned and reinforced with a drop structure made of gabion baskets that directs water flow over a central area onto a Reno mattress (rock held in place with wire) below which protects the soil and prevents a scour pool from forming below the new 'waterfall'.
- Geotextile fabric was used to protect the waterline where it will have to carry high velocity flows.

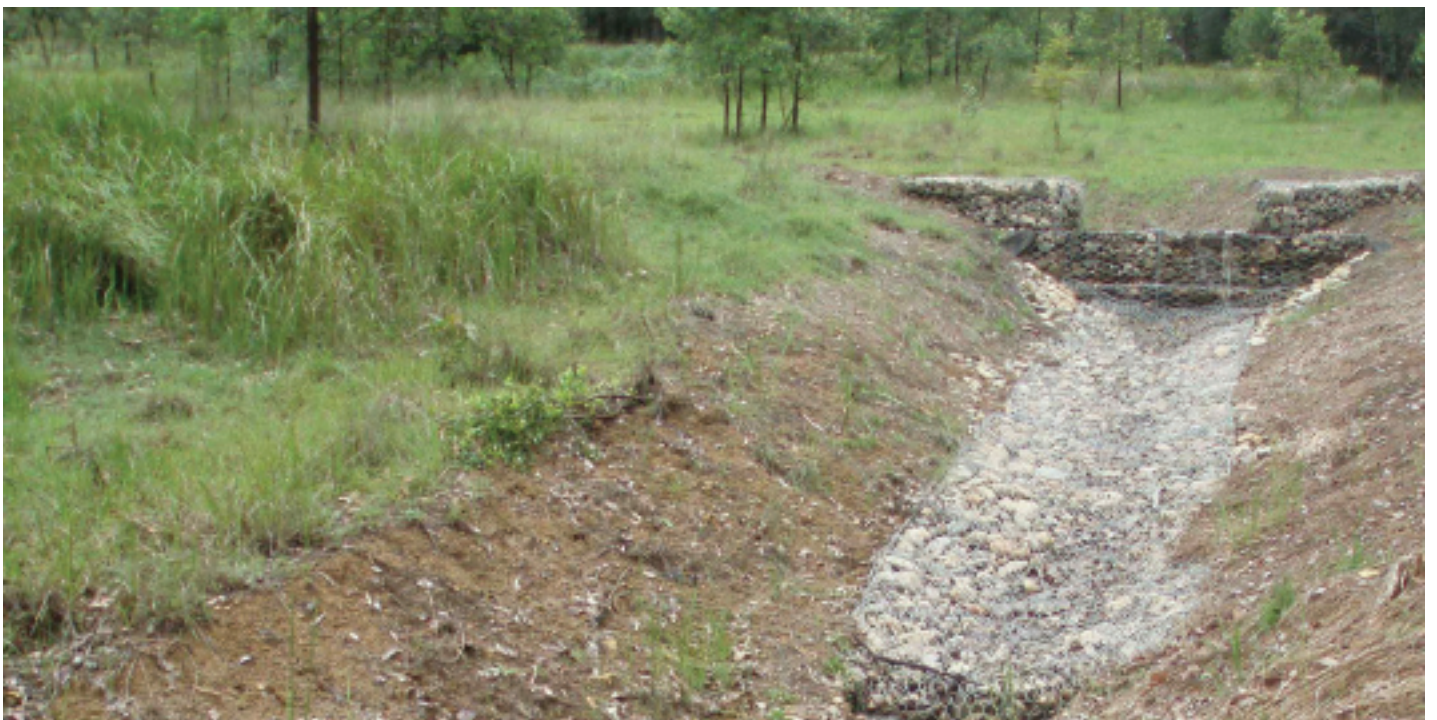
"The availability of advice and support by community natural resource support officer, Anne Gibbs and NSW DPI soils advisory officer Abigail Jenkins at all stages of the project greatly helped the implementation. The gabion structure coped with 500mm of rain from November 2007 till January 2008."

The gabion drop structure that stabilises the dam spillway
