Soil Erosion Solutions

Helping a hillside heal

The Site: behind the levee on the Clarence river the highly eroded hillside had been left for many years as it seemed too hard to find a viable solution.

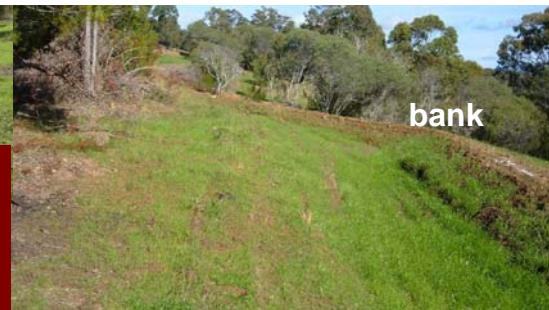
- The slope is now revegetated.
- Water and sediment no longer enters neighbouring properties.
- Water from upslope has been intercepted and no longer flows across the vulnerable area.
- Diversion drains break up the long steep slope and direct excess runoff to a sediment dam.
