# Soil Erosion Solutions

Helping North Coast landholders reduce soil erosion

Soil erosion projects completed  
in the Northern Rivers, NSW 2007/2008

Funded by Northern Rivers Catchment Management Authority

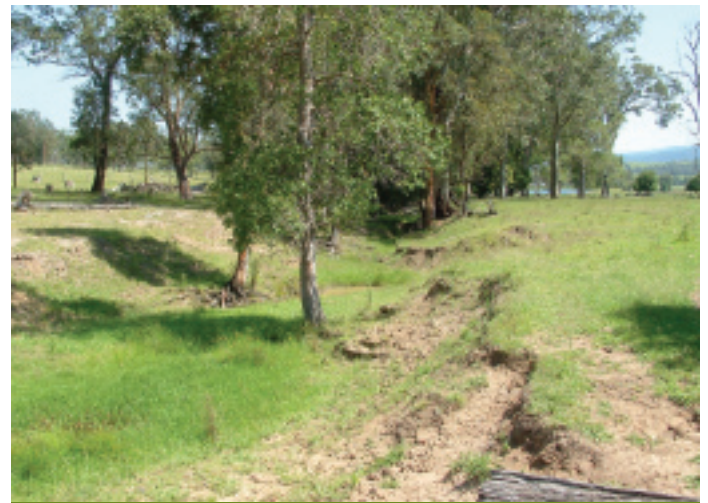
A failing dam within a gully line in remnant bushland had increased erosion. Access by cattle to the gully had contributed to the erosion and the failure of the dam.

Erosion in the gully

- The failing dam in the gully line has been decommissioned.
- An existing larger dam upstream of the gully was extended to increase water storage capacity, and so reduce water flows downstream.
- New fences were constructed and existing fencing repaired to exclude cattle from the watercourse, protecting the works area and existing remnant bushland.
- 50 local native trees were planted by the local Landcare group to improve soil stability and biodiversity.
- Weeds are being managed in the rehabilitation area.

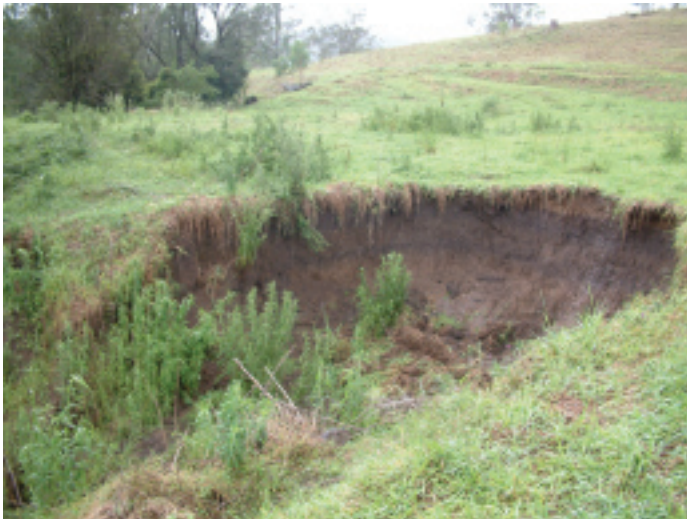
A deep gully had formed, running from highly erodible land into Iron Pot Creek. The head of the gully was dangerously undercut. A constantly wet track and stock access at the gully head encouraged further erosion and threatened productive cropping paddocks.

The gully head before works

- The area was fenced to exclude stock.
- A large concrete pipe was installed to deliver water from a collection sump behind the gully head to a concrete-lined 'stilling basin' on the bottom of the gully floor.
- The area around the stilling basin in the base of the gully was lined with concrete cores to protect the soil from turbulent water and to roughen the surface, reducing the speed of the water flowing from the basin.

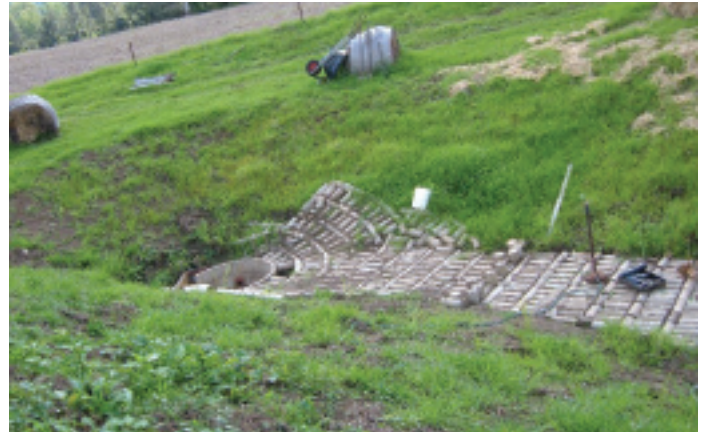
The reshaped gully head area

- Groundcovers were grown between the cores to further stabilise the soil.
- The sides of the gully were reshaped and planted with trees to halt further erosion.

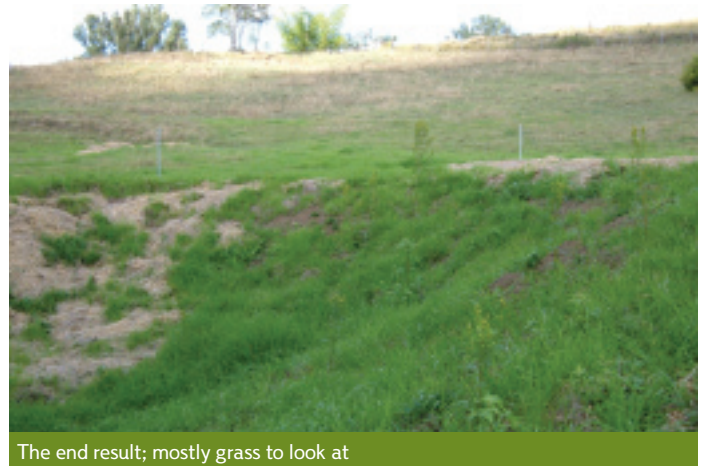
The end result; mostly grass to look at

- The gully head is now stabilised.
- The collection sump and stilling basin have reduced the erosive potential of the water coming through the gully.
- Less soil is washing into Iron Pot creek.
- The revegetated areas will help to link local vegetation corridors.

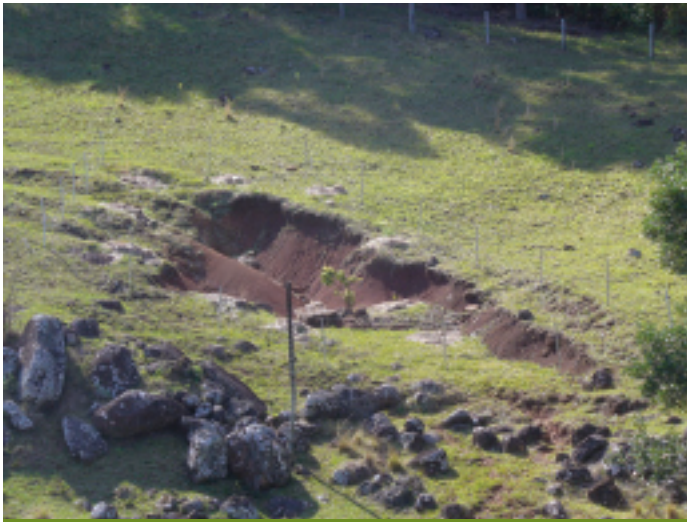
A steep property with a watercourse flowing through the centre had numerous slip areas, several of which had developed into gullies.

One of the gullies just after fencing and planting

- Slip and gully erosion areas were fenced to prevent stock access worsening the erosion.
- Rainforest trees were planted to remove water from the soil profile and hold the soil in place with their deeper root systems.

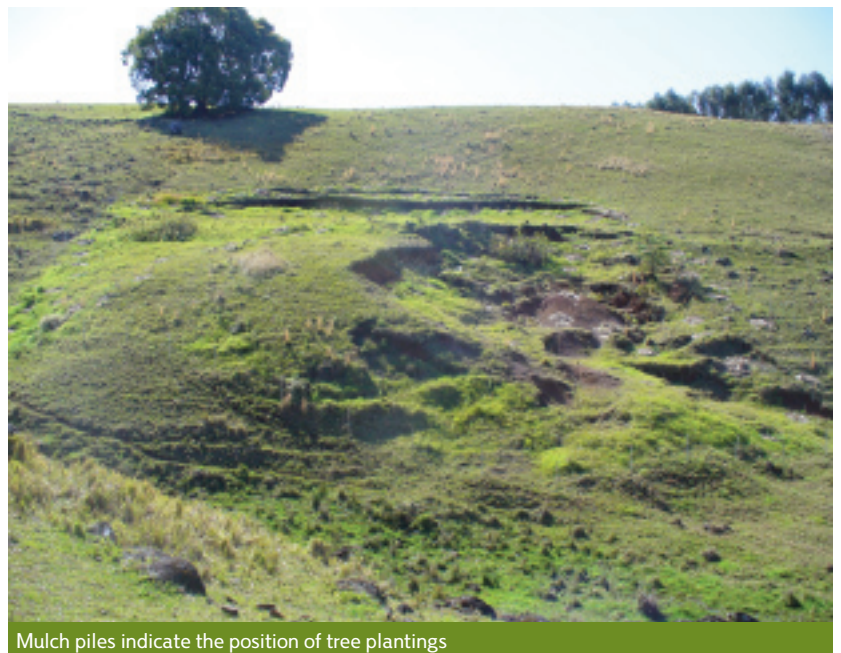
Mulch piles indicate the position of tree plantings

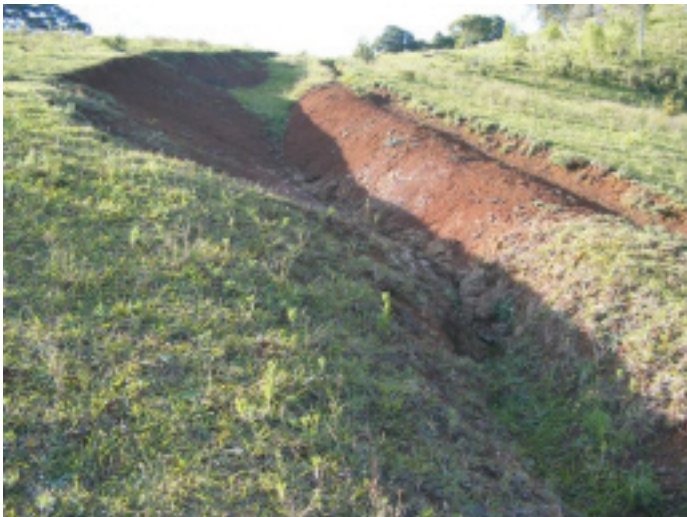
A stock track on a steep slope had initiated a gully that had grown to 160 metres long and up to 2 metres deep. Soil from the gully was ending up in the nearby creek.

The gully before works

- Cattle were excluded from the gully.
- Check dams of rock and geotech fabric were built at intervals down the gully.
- Some sections of the gully were lined with geotech fabric and filled with rock.
- The filled area was mulched over to allow grassing over.
- Trees were planted alongside the gully.

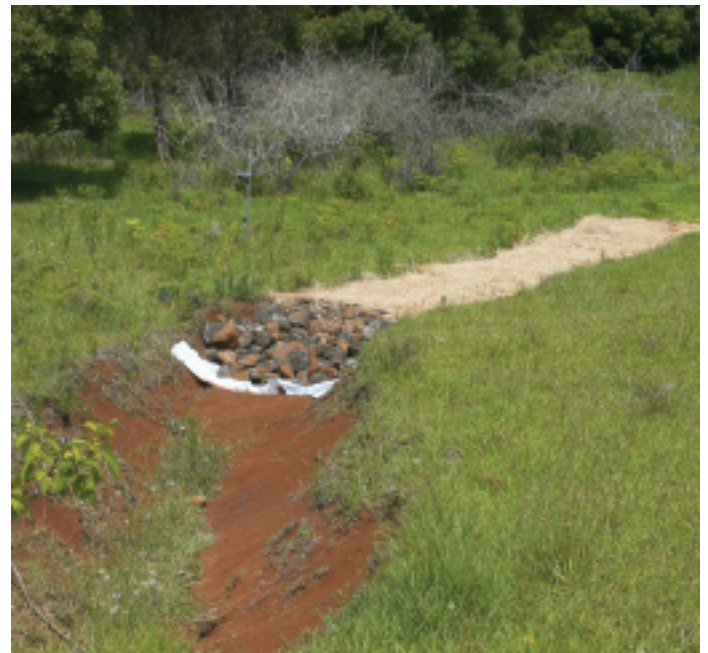
Filling and mulching of the gully

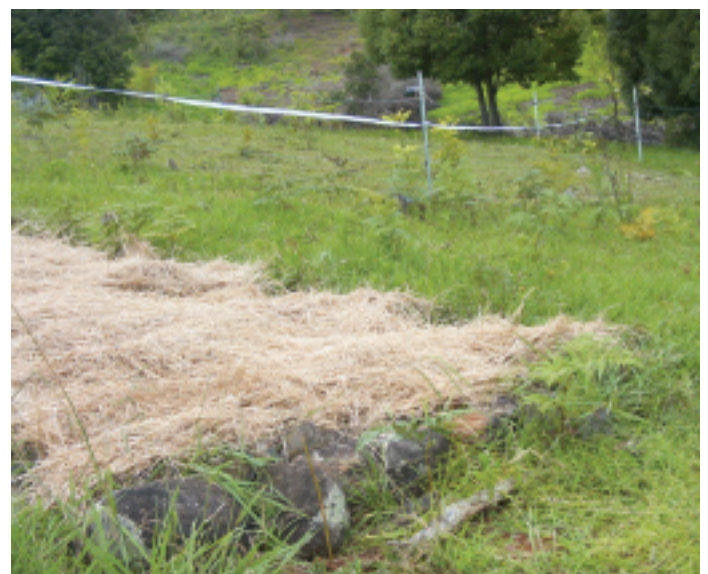
The bottom of the filled gully with tree plantings behind

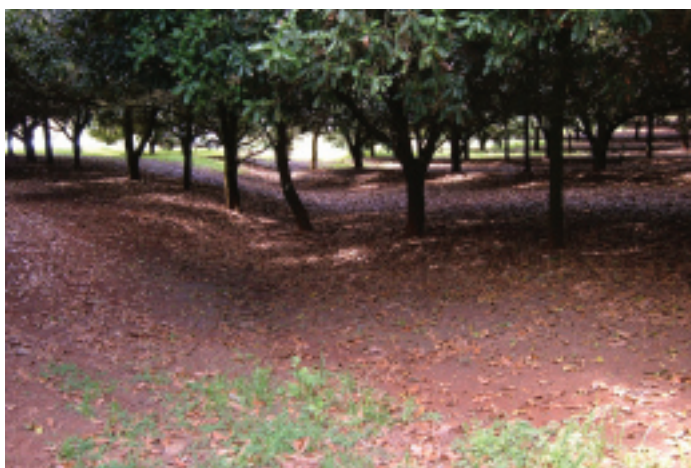
An older macadamia orchard with a nearly closed canopy had been established with little regard for natural watercourses. As a result there was extensive sheet erosion with exposed tree roots, and gullies had formed where waterflows concentrated in the orchard. The damage to the orchard floor meant machine-harvesting in those areas of the orchard was ineffective. A new owner wanted to reduce the dramatic soil loss and improve machine-harvesting while maintaining existing production levels.

Low light levels and tree rows cutting across natural drainage lines

- Gullies running down the interrows were filled with large gravel. Some trees were removed and others pruned to assist grass cover to be established over the top of the gravel, permitting machine-harvesting. The filled gully functions as both a subsurface and surface drain.
- Where water flowed across the tree rows small rock check dams were installed to slow the water down and encourage sediment deposition.
- Selected trees growing in natural flowlines were removed.
- Windbreak trees causing excess shading were removed.

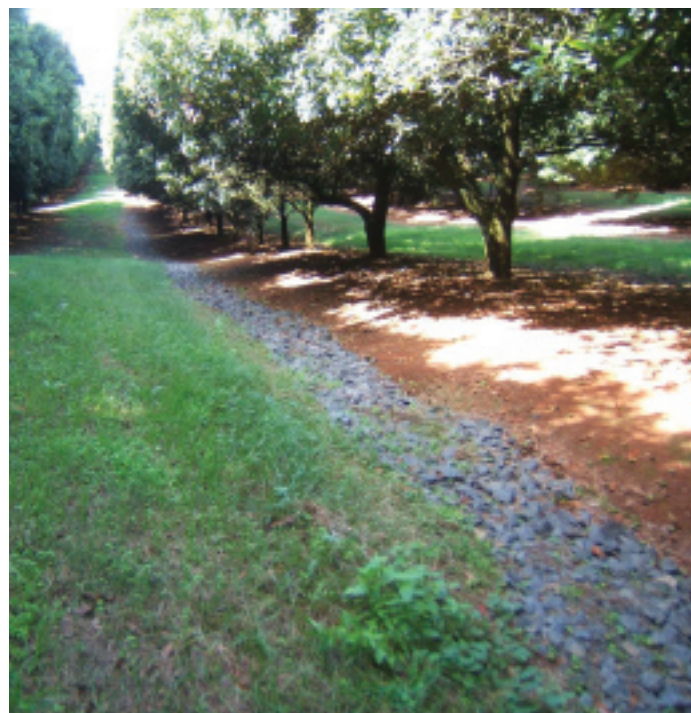
Rock fill in a gully protects against further erosion

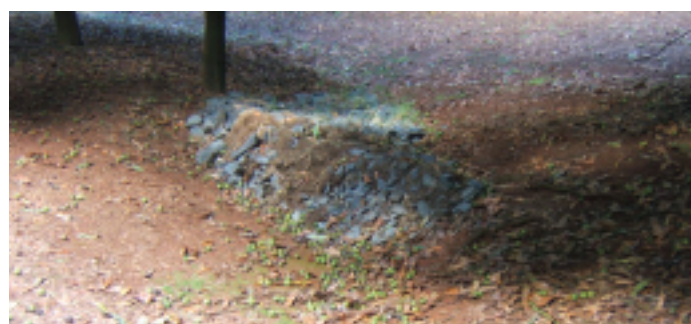
A small check dam protects where water crosses the tree line

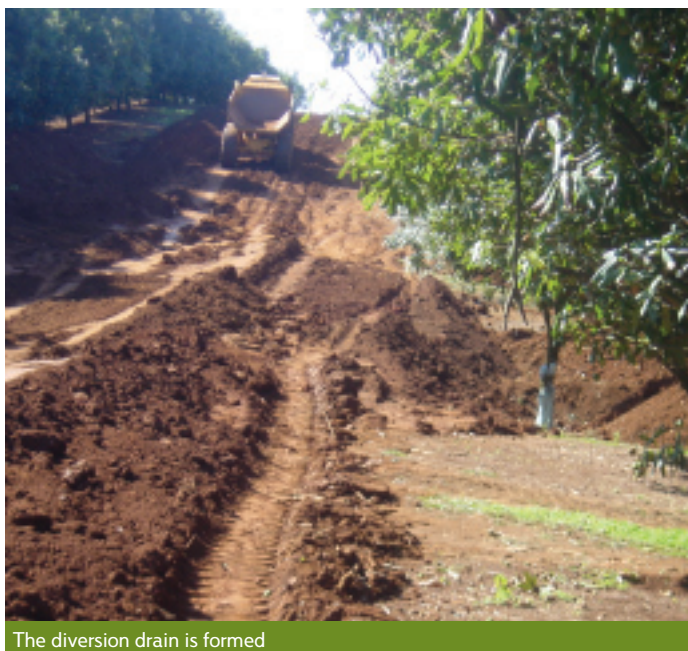
The diversion drain is formed

- The windbreak between the two properties was removed and mulched.
- A broad shallow diversion bank was constructed along the boundary to divert water to the farm dam and into a nearby stable watercourse.
- Excavated soil was used to form low profile mounds along the adjoining eroded tree rows.
- Jute erosion control matting was installed in the high flow area of the new drain to give immediate protection.
- Carpet grass and winter ryegrass were sown in all disturbed areas.

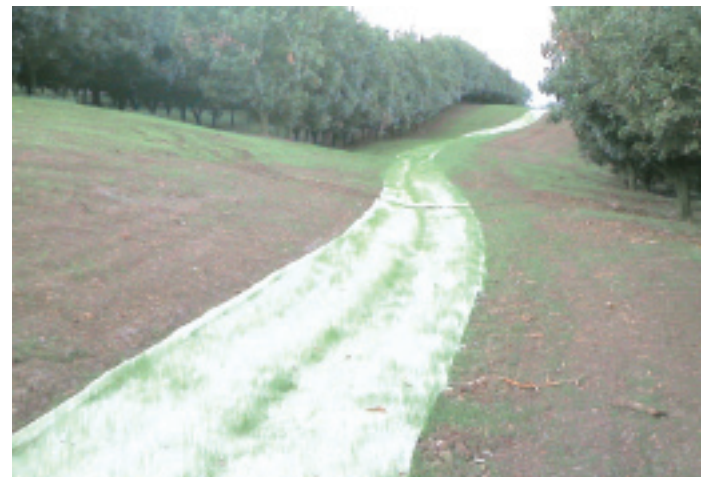
Jute erosion matting laid in the new drain's flowline

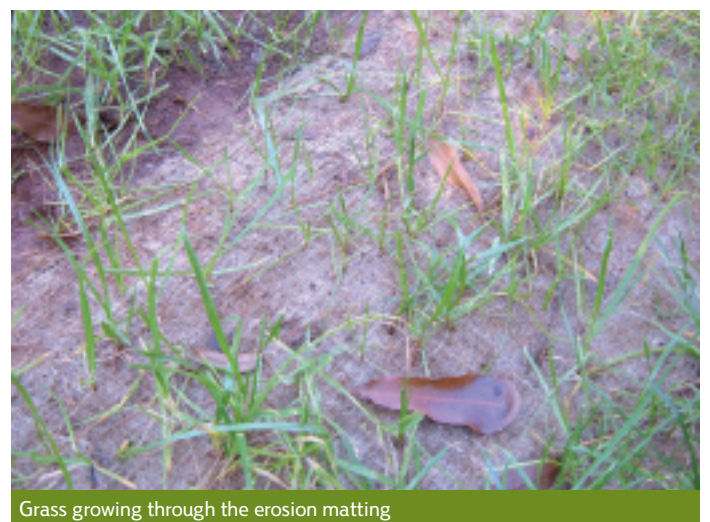
Grass growing through the erosion matting

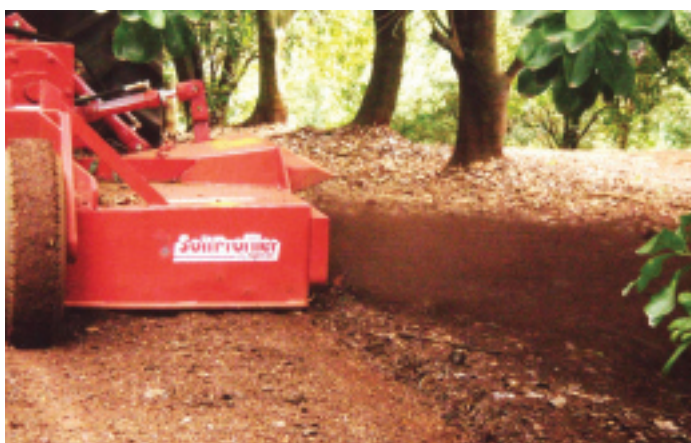
The soil profiler shifts soil from the interrow into the tree row

- Trees next to watercourses were pruned heavily to allow more light through for grassed waterways.
- Trees were hedged on one side to increase light availability on the orchard floor.
- The interrow soil was reprofiled to cover tree roots and form wide shallow spoon drains.
- Compacted soils were improved with a spike aerator.
- Smothergrass plugs were planted at each tree.
- Millet seed was sown over all disturbed soil areas.

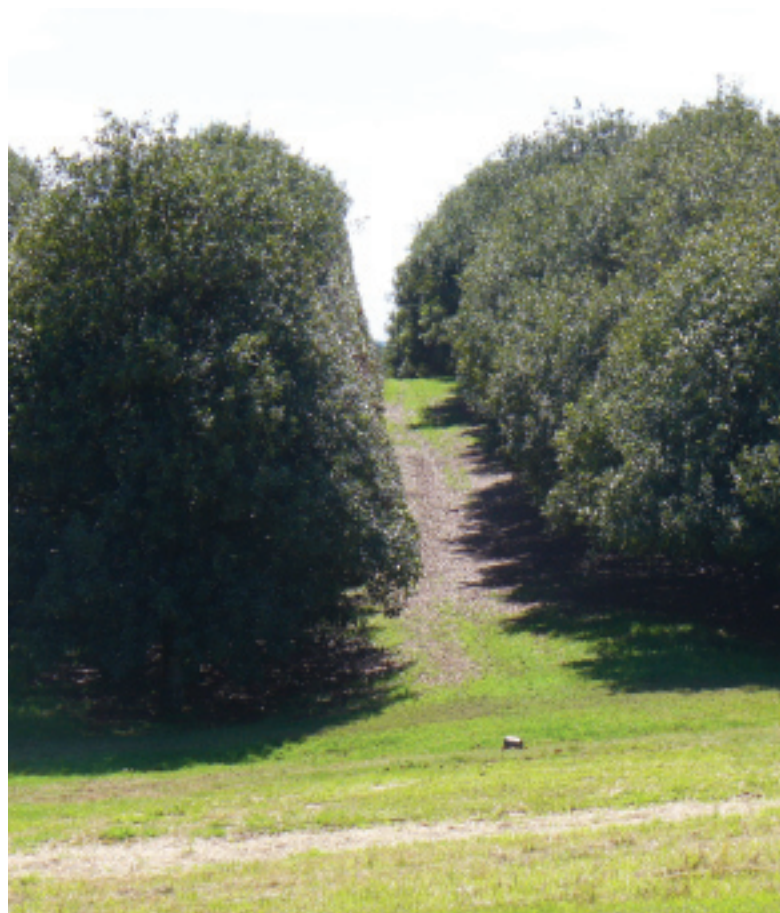
Hedging of one side of the trees

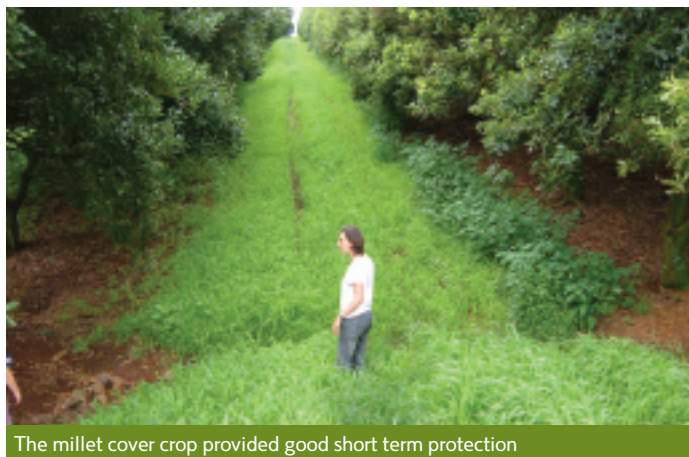
The millet cover crop provided good short term protection

“Timing of works with the rainfall. It was difficult to get cover to hold the very loose soil so it did not wash away with the first lot of rain.”

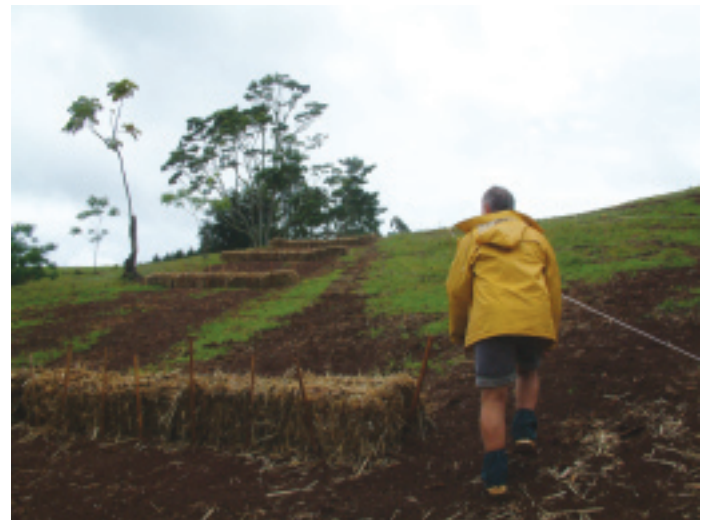
Hay bales slow down water on a steep slope

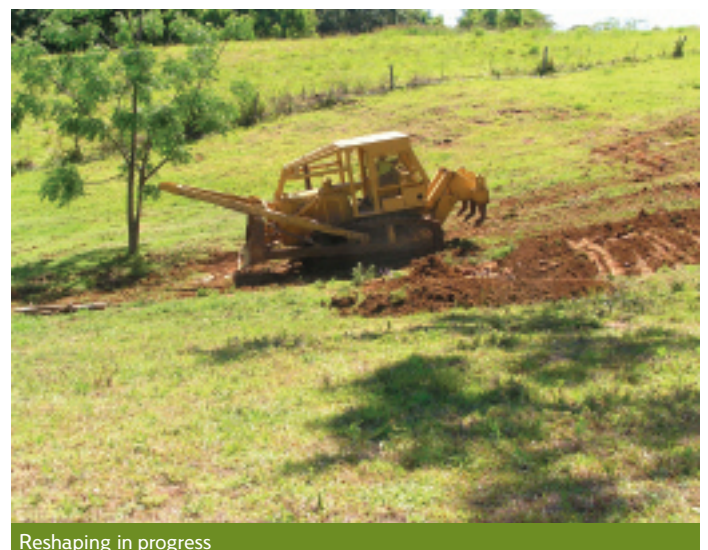
Reshaping in progress

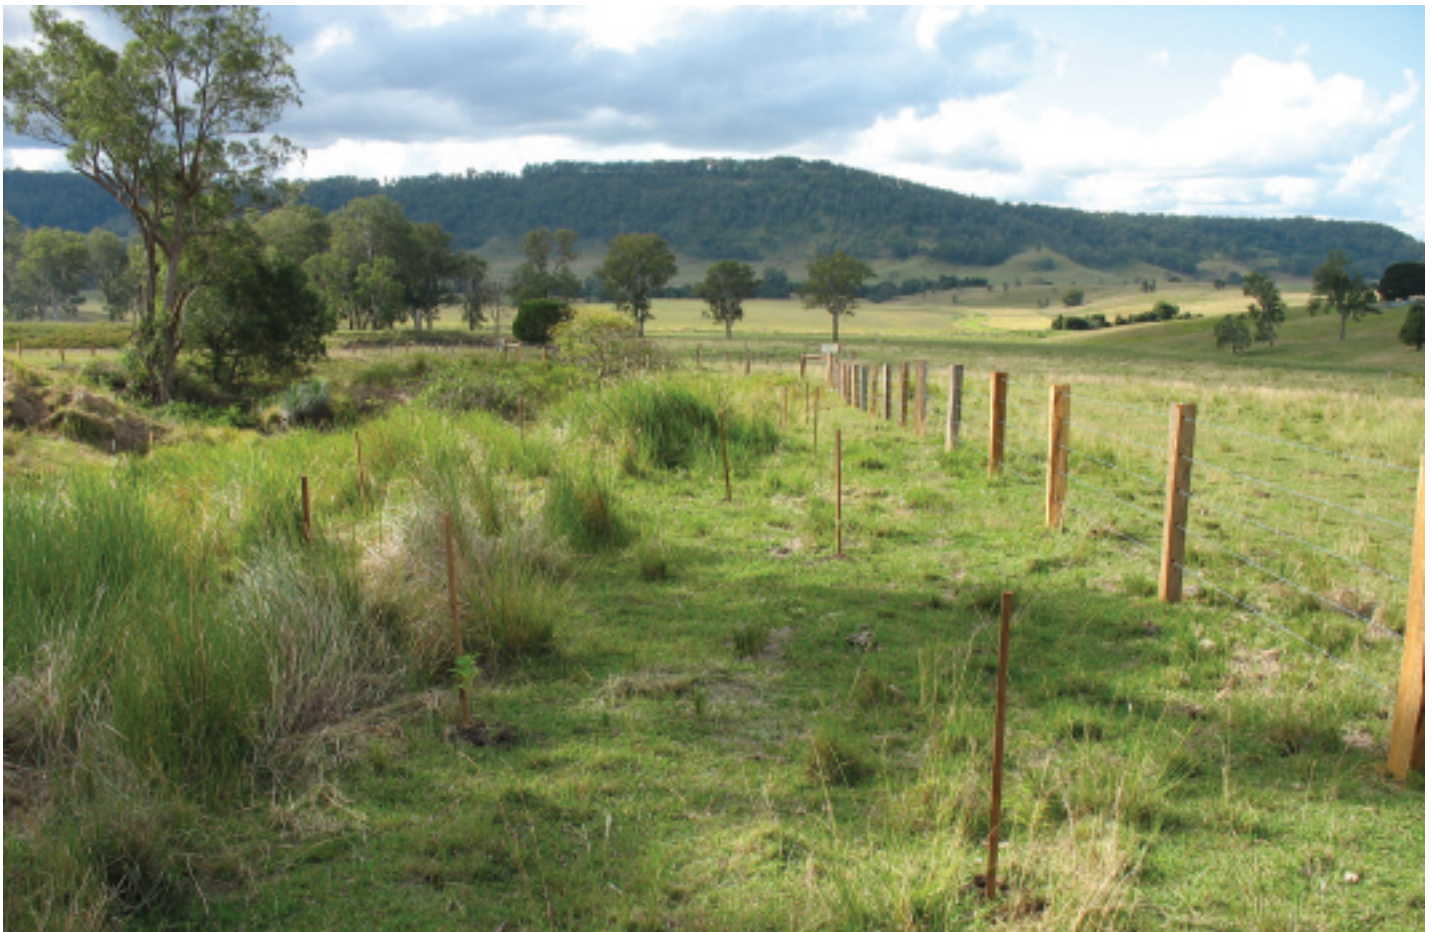
The fenced off watercourse

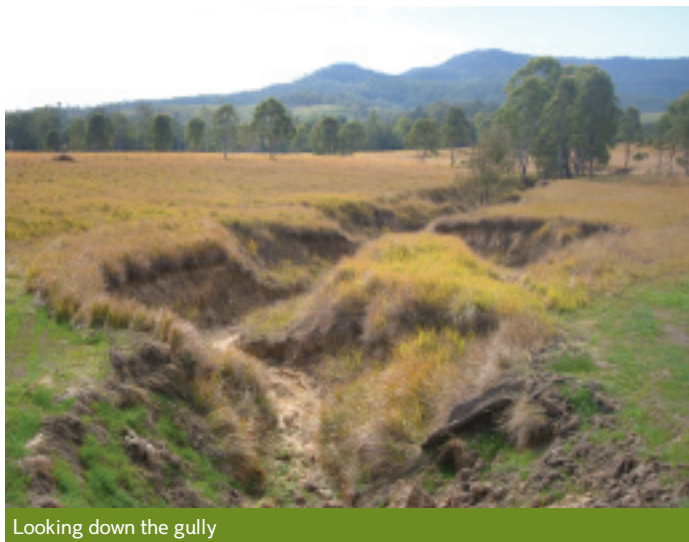
The landholders of this remote grazing property with dispersive subsoils were concerned about several active gullies. One of the worst gully heads had already cut its way over a kilometre up a broad valley, cutting a gully over 5m deep and often over 25m wide. We wanted to stop the advance of the headcut into productive pastures.

Looking down the gully

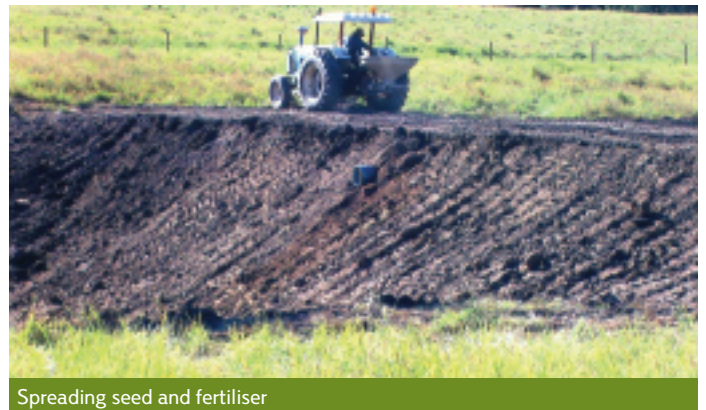
Spreading seed and fertiliser

7. Topsoil was respread over the finished wall, then fertilised and seeded with perennial grasses and a cover crop of oats.
- The pipe outlet in the base of the gully was armoured with rock.

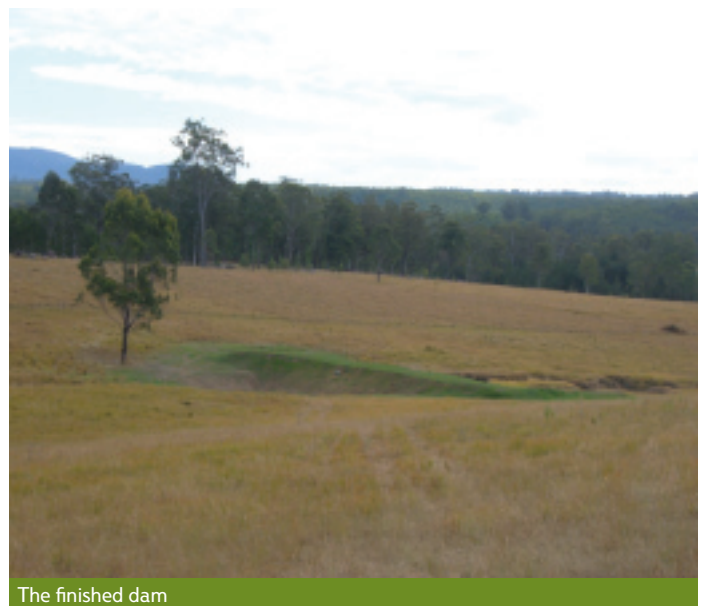
The finished dam

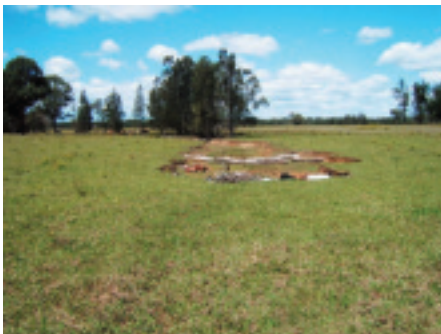
The gully before works

An active gully head had developed in a transitional area where a broad depression carried flood overflow from a wetland into a defined creek line. The open country and very gentle slope of the site allowed the creation of a preferred flow line around the gully area.

- Above the gully head a back push diversion bank was constructed. This ensured the diverted water ran along undisturbed ground and dense vegetation. The diverted water runs around the gully area and is directed back into the natural creekline further downstream.

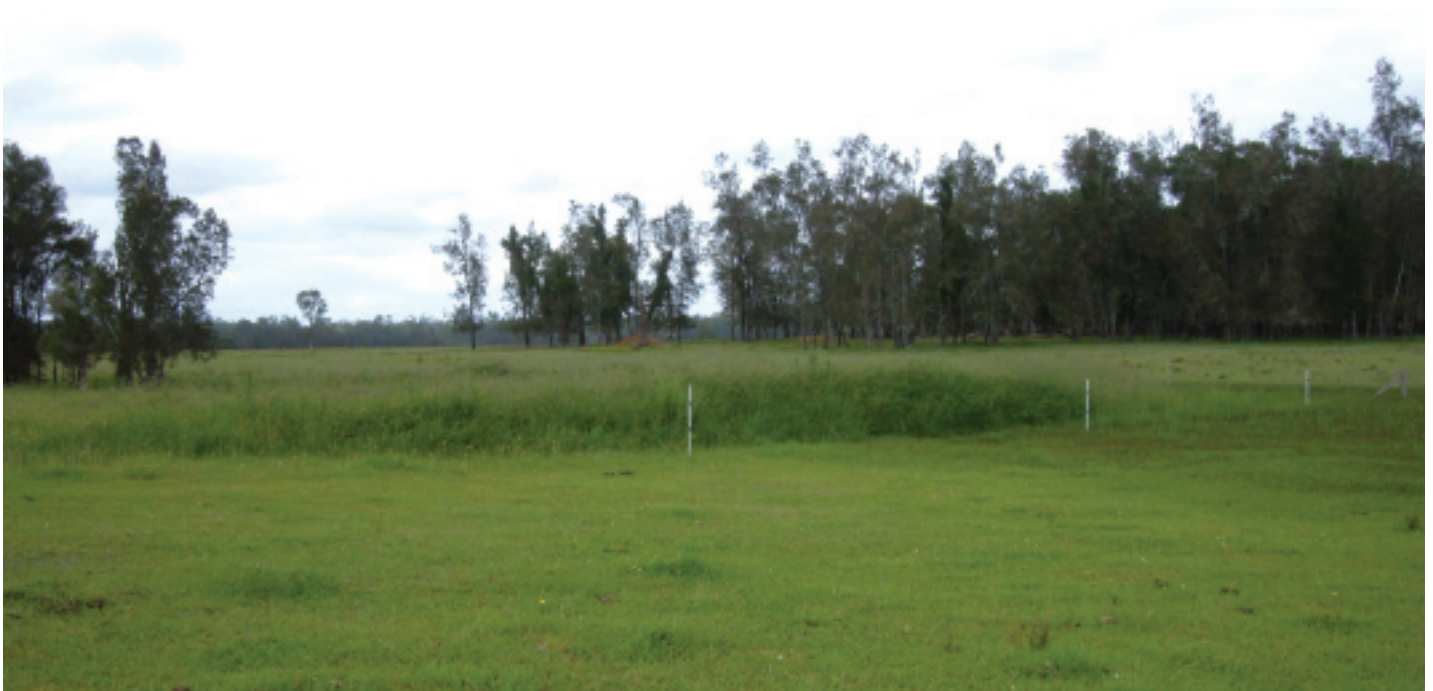
The diversion bank seen from upslope

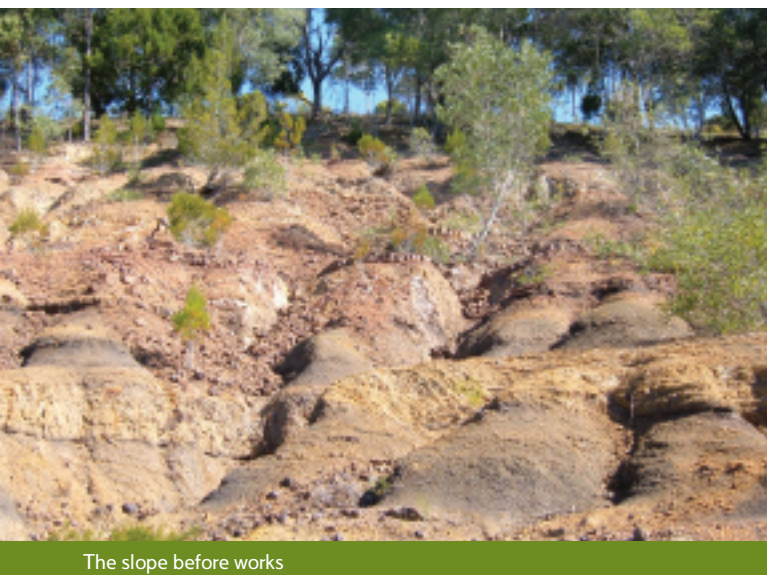
The slope before works

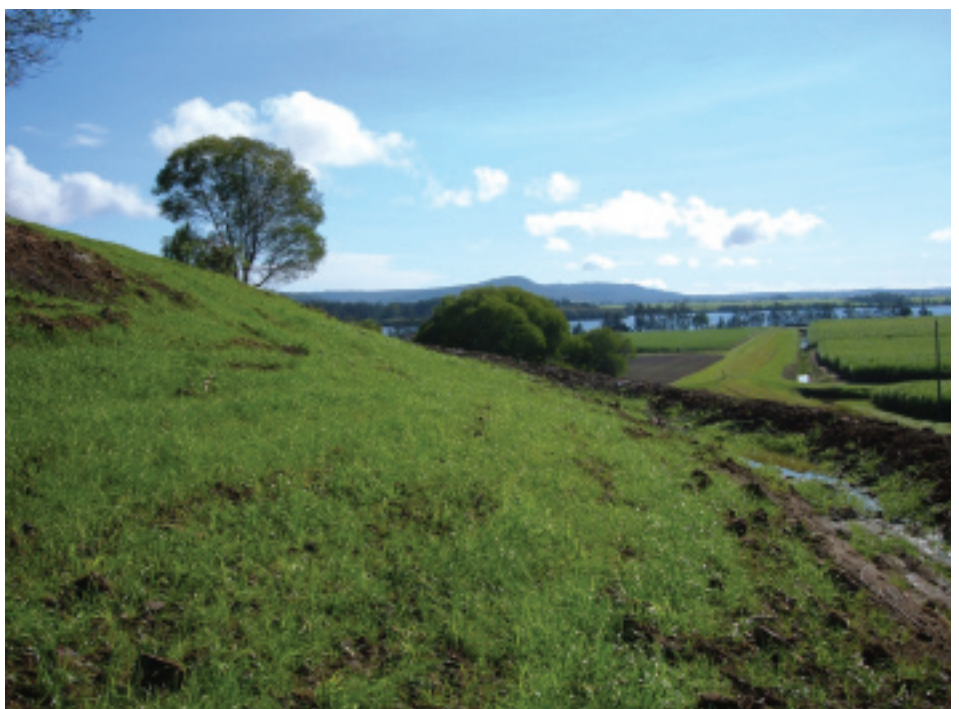
The rehabilitated site

- A very degraded site has been largely stabilised
- Any further eroding soil is being caught in the sediment dam.
- The establishment of native trees and shrubs on the site has increased its conservation value.

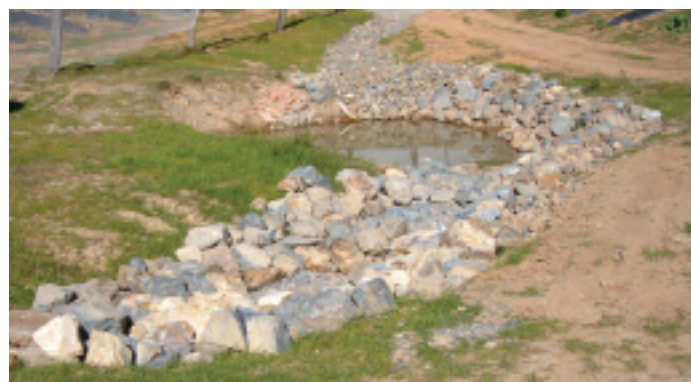
The new sediment basin with rocky outlet

- A soil conservation plan for the blueberry area was prepared with the NSW Soil Conservation Service.
- A gravel bank was constructed to stop water from the road running down an orchard track.
- Long blueberry rows were broken up with cross banks to intercept run off water and deliver it safely to managed watercourses.
- The central drainage line was improved with subsurface drainage.
- The capacity of the existing sediment basin was increased, and scour areas protected with rock.
- Disturbed soil was fertilised, seeded with grasses and mulched.
- Small erosion points at the edge of blueberry mounds were protected with geotextile sandbags to direct water flows into the grassed interrows.

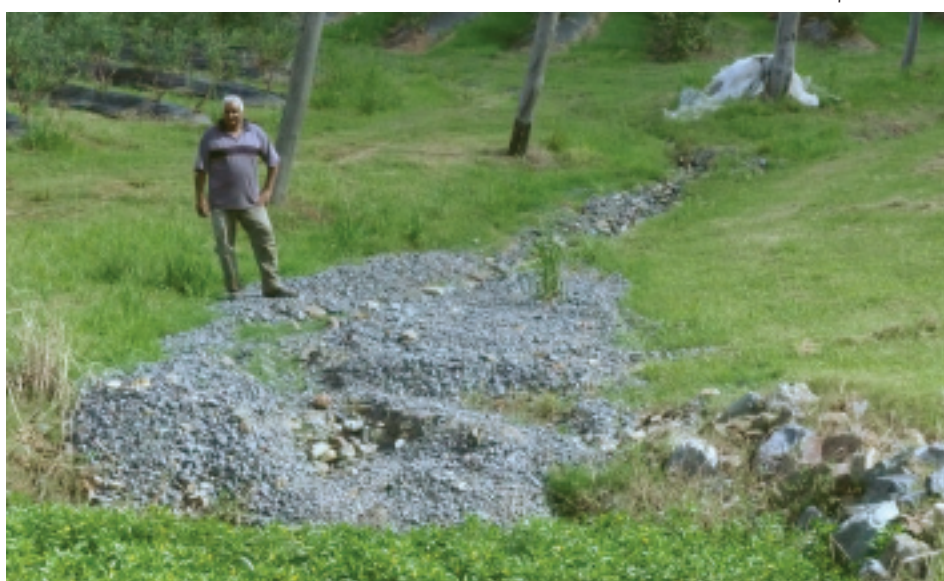
Subsurface drainage improves the central flow line

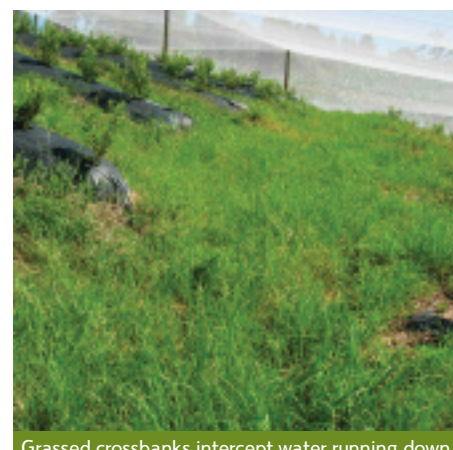
Grassed crossbanks intercept water running down the blueberry rows
