Gully stabilisation

Landholder	Frank Paice
Map reference	1
Land use	Cabinet timber
Soil Erosion Solutions Grant	\$10,000 (earthworks, concrete)
Landholder's in-kind contribution	\$10,321 (labour, rocks, plants)

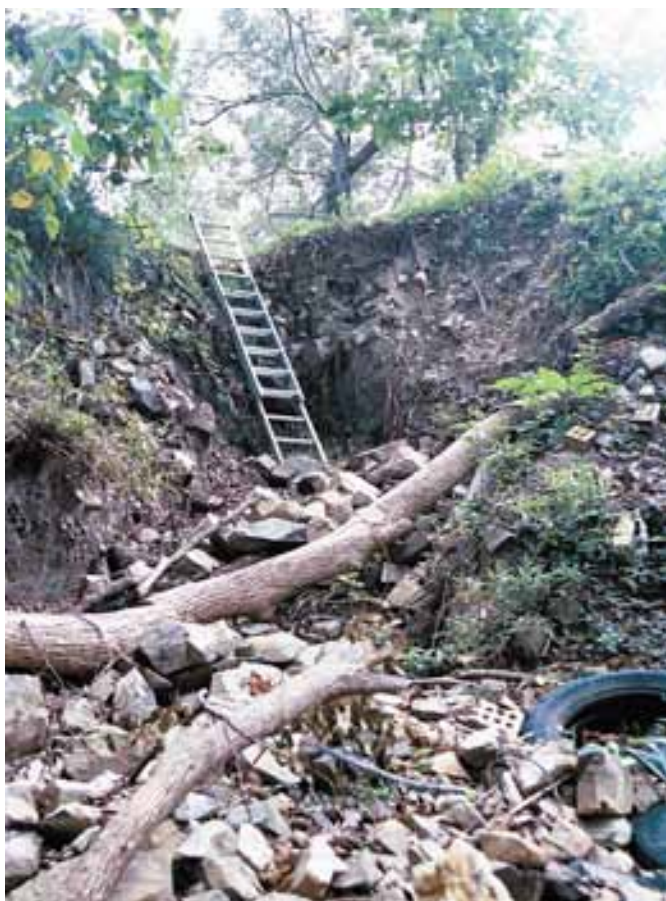
On the low side of a sweeping bend, concentrated run-off from a bitumen road contributed to severe gully erosion running into remnant rainforest. The gully was damaging the forest and cutting into a residential site close to sheds and driveways.

Cudgen property before works

- > A waterfall structure made from large boulders was constructed to protect the gully head.
- > An upstream channel was constructed to reduce seepage, slow the water and direct the water over the new structure.
- > Trees and grasses were planted to stabilise other parts of the gully.

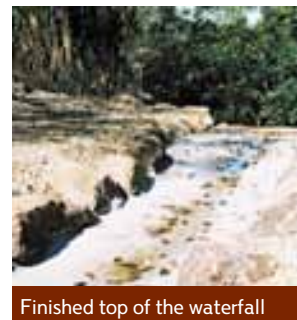
Finished top of the waterfall

"The system for controlling the water running off the road works perfectly. The wide flat channel serves to slow the water before flowing over the waterfall structure; the water is then controlled downstream with the use of Australian native trees, grasses and Vetiver grass."

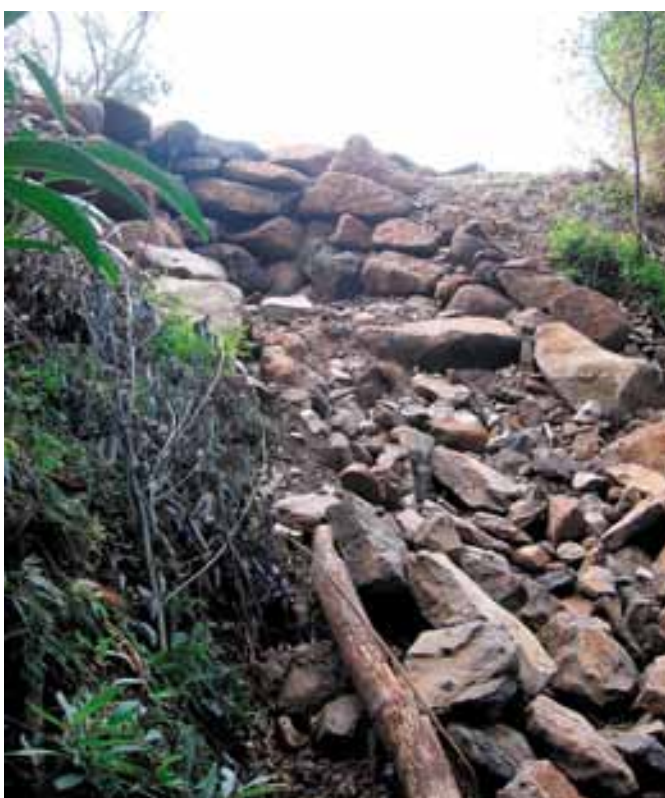
Finished works
