ASHUA Improved orchard drainage and groundcover

Landholders	Frank and Terry Adcock
Map reference	5
Land use	Macadamias
Soil Erosion Solutions Grant	\$1,675 (earthworks, haybales)
Landholder's in-kind contribution	\$1,700 (planning, smothergrass, labour)

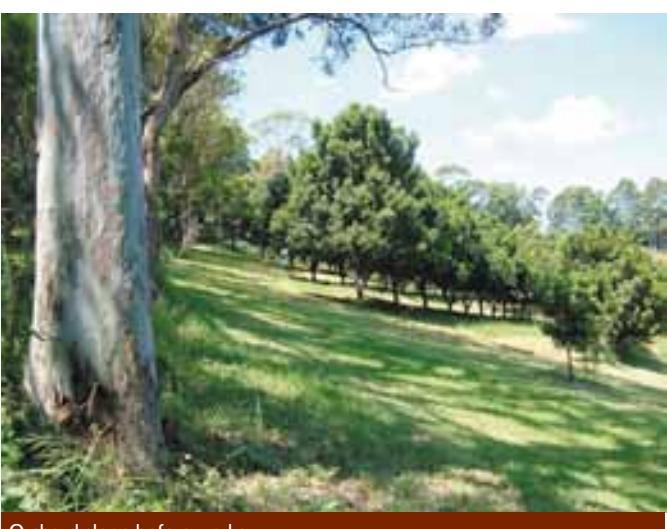
This is a young 4ha orchard, with good grass cover and little erosion, but some sections are relatively steep and the landholders are aware of the increasing erosion risk as their orchard matures.

Orchard slope before works

- > Where possible runoff was diverted towards the centre of the property to assist with filling the farm dam.
- > Spoon drains were formed in selected interrows.
- > The disturbed soil was sown with winter rye grass and sorghum to provide fast groundcover.
- Hay bales were placed within the spoon drains to slow water flow, encourage infiltration and trap sediment. The bales will be replaced by earth swales after groundcover establishes in the new drain.
- > Pots of shade-tolerant smothergrass were planted out.

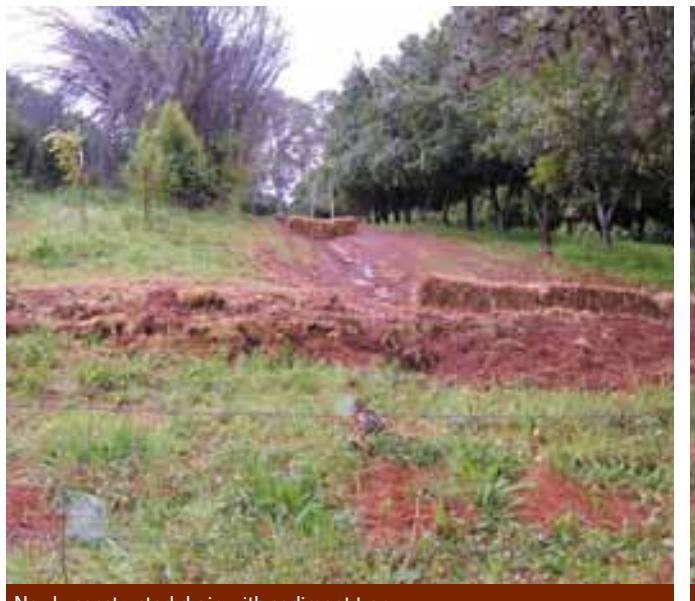
Newly constructed drain with sediment trap

- > Potential erosion has been prevented.
- > Improved orchard drainage fills the farm dam and increases rainfall infiltration.
- > Groundcover will survive as the orchard matures.
