## reshaping gullies and return to pasture

<b>Landholder</b>	Keith Doherty
<b>Map reference</b>	10
<b>Land use</b>	Grazing and future cabinet timbers
<b>Soil Erosion Solutions Grant</b>	\$5,940 (hire of earthmoving equipment, purchase seed and mulch)
<b>Landholder's in-kind contribution</b>	\$5,940 (labour, tractor work)

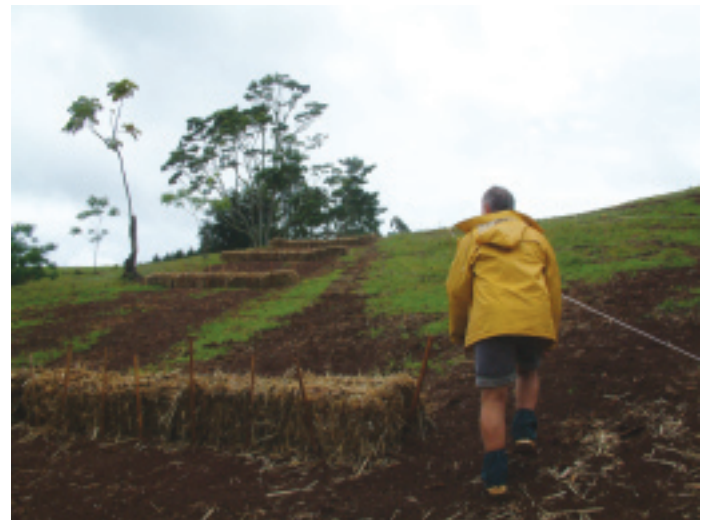
Hay bales slow down water on a steep slope

- Cattle were temporarily excluded from the rehabilitation sites.
- Some gates and sections of fences were removed to allow access for machinery.
- Eroded sections were reshaped, lined with rock and covered with topsoil.
- One very steep slope was terraced to slow down water flow.
- Slopes were detailed to allow slashing for maintenance.
- Disturbed soil was fertilised, seeded with grasses and mulched.
- Straw bales were placed across slopes to minimise soil and seed loss.

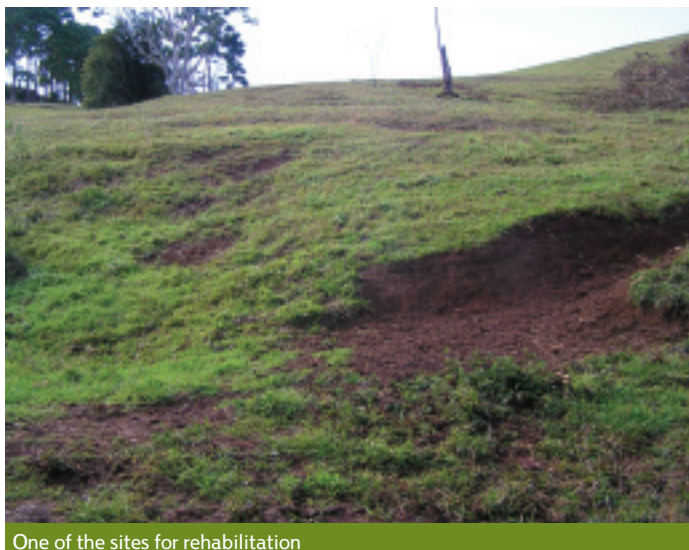
One of the sites for rehabilitation

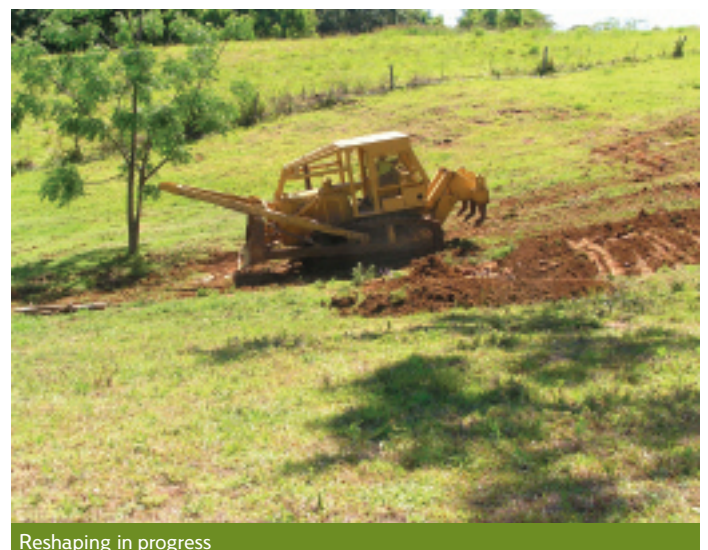
Reshaping in progress
