Stabilising banana tracks

Landholders	Jinderpal Rai and Mohinder Singh
Map reference	8
Land use	Bananas, avocados, blueberries
Soil Erosion Solutions Grant	\$9,000 (excavator hire, gravel, native plants)
Landholder's in-kind contribution	\$10,300 (labour, tractor, excavator hire, gravel, cement, grass seed)

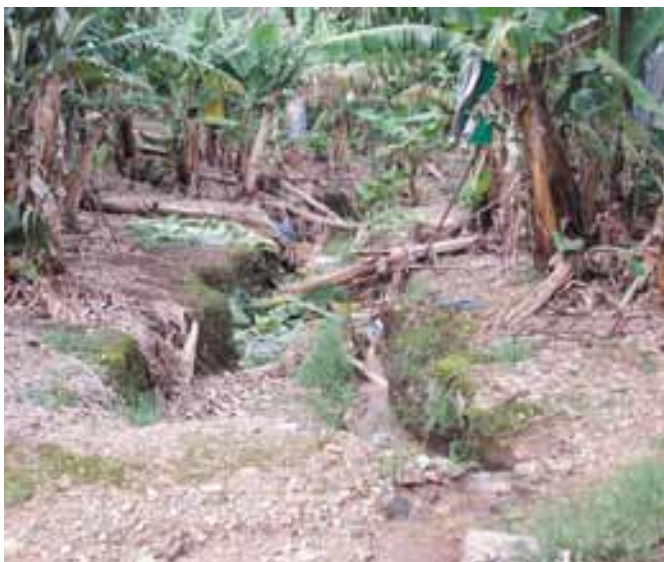
The owner had difficulty maintaining vehicle access on the steep slopes of this working banana plantation. The alignment and condition of the access tracks for this banana plantation were creating gullies and making vehicle access increasingly difficult. A new blueberry orchard was also losing soil from bare ground between the rows.

Gully through banana plantation

- > Erosion banks were installed to divert water off the tracks and reduce the velocity of the water moving downhill.
- > Tracks were reshaped using gravel, pipes, concrete and rock.
- > All areas disturbed by the erosion control works, including track surfaces, were seeded with grass.
- > The blueberry orchard floor was stabilised with a cover crop of grass.

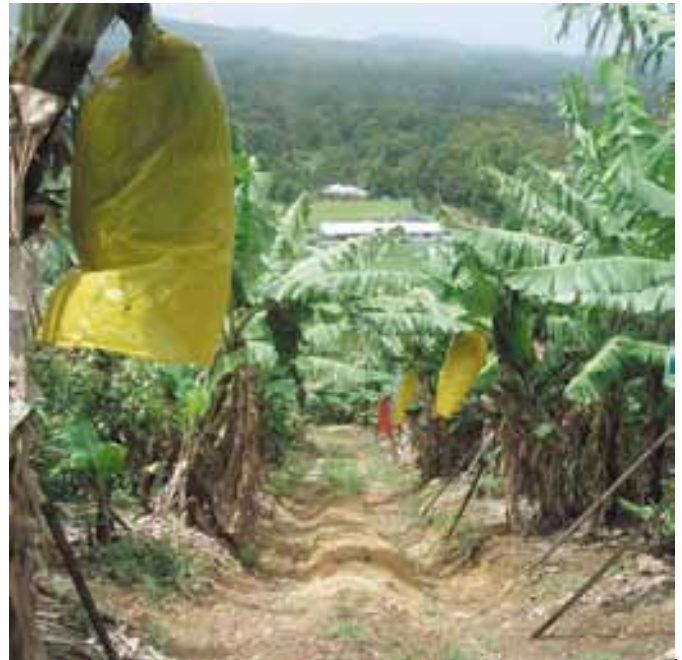
Eroding banana track

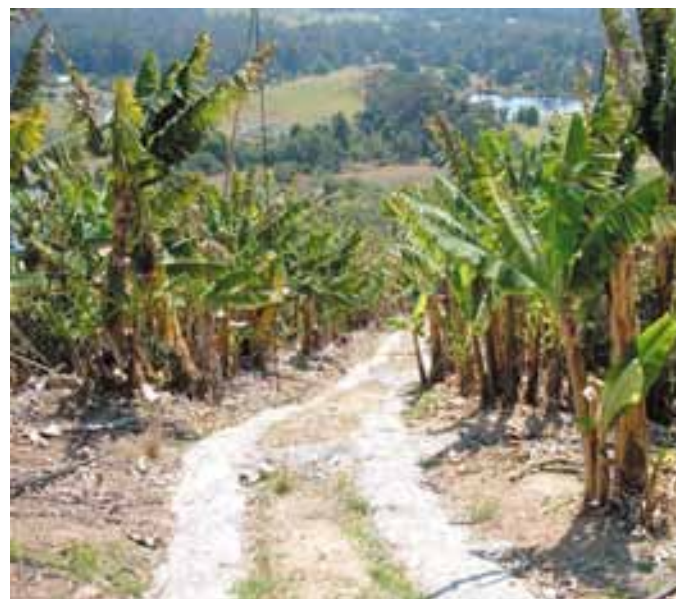
After the works : repaired banana track
