Orchard floor improvement

Landholder	Rex Harris
Map reference	4
Land use	Macadamias
Soil Erosion Solutions Grant	\$9,342 (equipment hire, soil conditioners, smothergrass turf)
Landholder's in-kind contribution	\$11,598 (labour, tractor work)

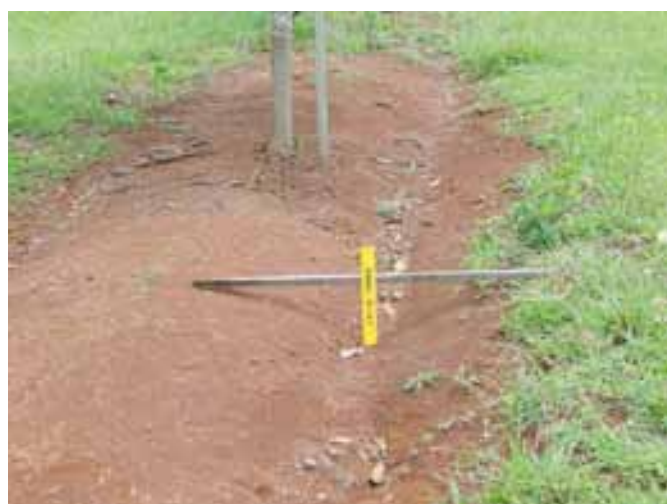
This young macadamia orchard had erosion and washouts between tree rows due to groundcover decline from lack of light. Runoff from the site was flowing into Skinners Creek.

Eroded channel next to macadamia tree showing exposed tree roots

- > The orchard floor was reshaped to create a wide spoon drain down the centre of the interrow.
- > The interrow topsoil was placed under the trees.
- > Shade-tolerant sweet smothergrass was established by laying turf in strips across the new spoon drain, each strip acting as a sediment trap until vegetation could spread across the whole area.
- > Biological activity in the soil was stimulated by application of a vermi-compost extract and PBS (Phyto Biological Stimulant, made from kelp, fulvic acid, fish emulsion, molasses, selenium, boron and zinc) to improve soil structure by increasing the stability of soil aggregates.

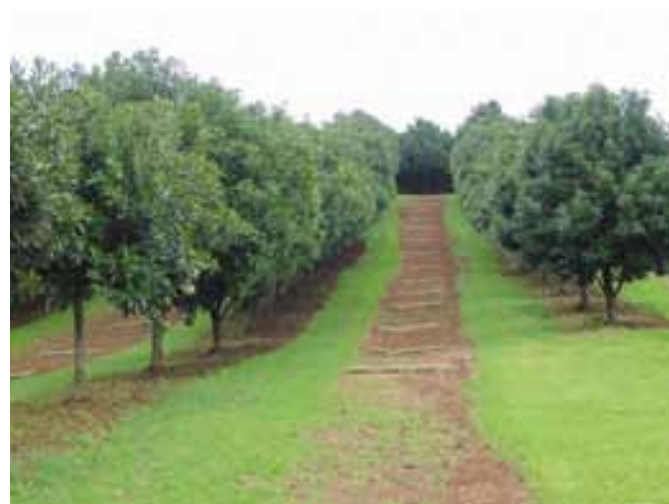
Shade-tolerant smothergrass turf strips laid between the orchard rows

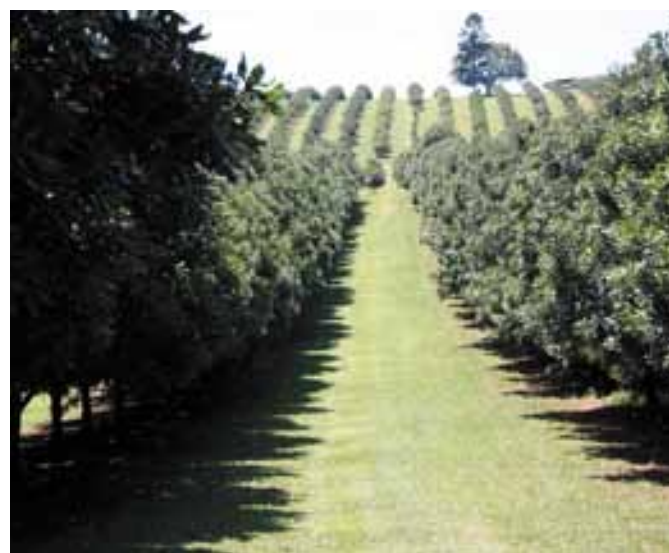
After the works: good grass cover between the orchard rows

- > Sediment loss to Skinners Creek has been reduced.
- > The shade-tolerant groundcover will improve soil biological activity and soil health.
- > Improved soil structure will reduce the soil's erodibility.
