Moving out of bananas

Landholders	Jeff Herdegen and Vanessa Crompton
Map reference	10
Land use	Bananas
Soil Erosion Solutions Grant	\$7,300 (surveying, clearing bananas, earthworks, grass seed, trees)
Landholder's in-kind contribution	\$7,740 (surveying, clearing bananas, earthworks, revegetation, building retaining walls)

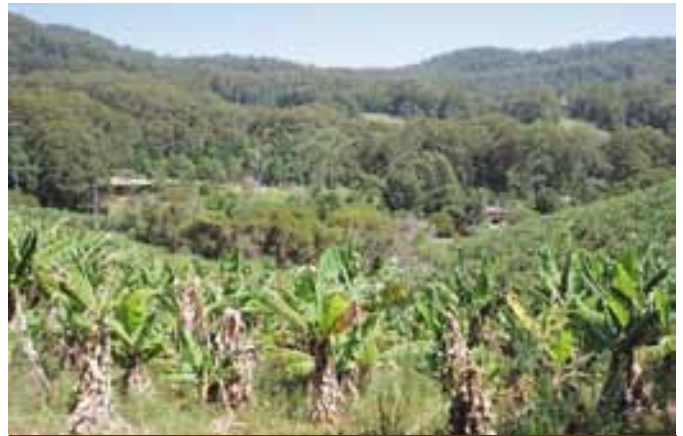
Steep slope planted out with natives

- > The site was surveyed to define the slope contours.
- > The bananas were cleared with ongoing management of weeds.
- > Contour banks were built to slow the flow of runoff water.
- > A dam was built to trap runoff sediment.
- > Rills and gullies were stabilised with rock fill.
- > Trees were planted in belts on the contour for long term stability.
- > Fencing was upgraded.

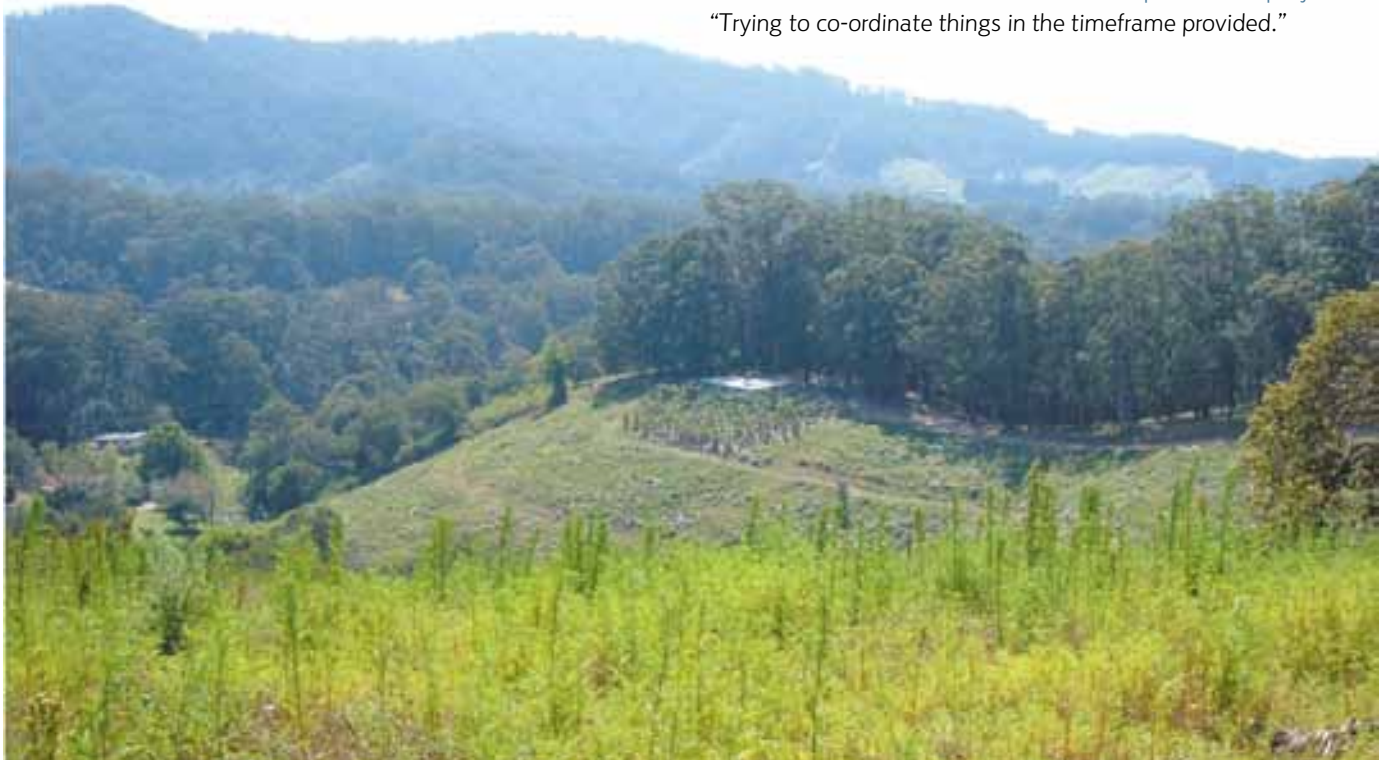
Bananas cleared
