soil conservation on a blueberry farm

Landholder	Sohan Atwal
Map reference	16
Land use	Bananas and blueberries
Soil Erosion Solutions Grant	\$9,300 (gabion rock, gravel, cracker dust, pipes, excavator hire, geofabric sandbags, grass seed)
Landholder's in-kind contribution	\$9,300 (labour, tractor work)

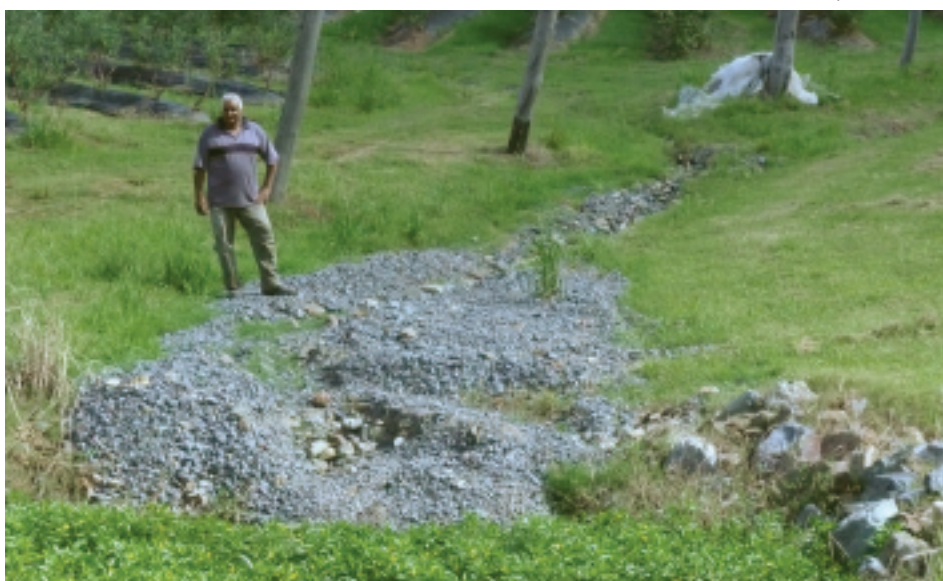
Subsurface drainage improves the central flow line

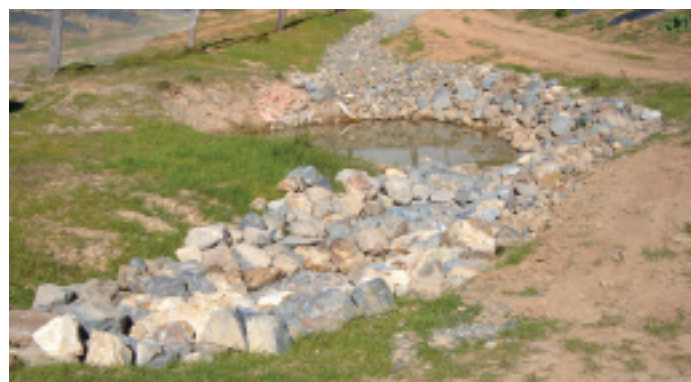
The new sediment basin with rocky outlet

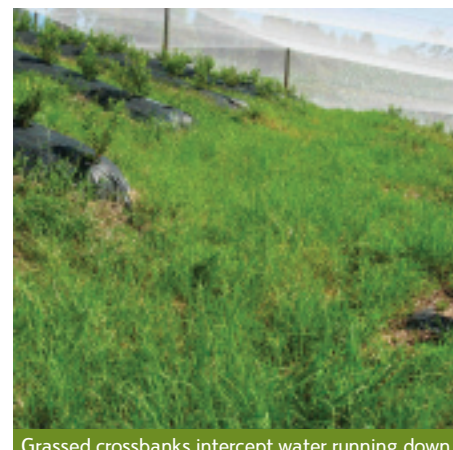
Grassed crossbanks intercept water running down the blueberry rows
