# Soil Erosion Solutions

## An end to gully erosion

**Landholder:** Margaret Duffield and Peter Stackhouse  
**Location:** Upper Richmond catchment  
**Land use:** grazing and cropping  
**Soil Erosion Solutions Grant:** \$3,900  
**Landholder's in kind contribution:** \$4,010

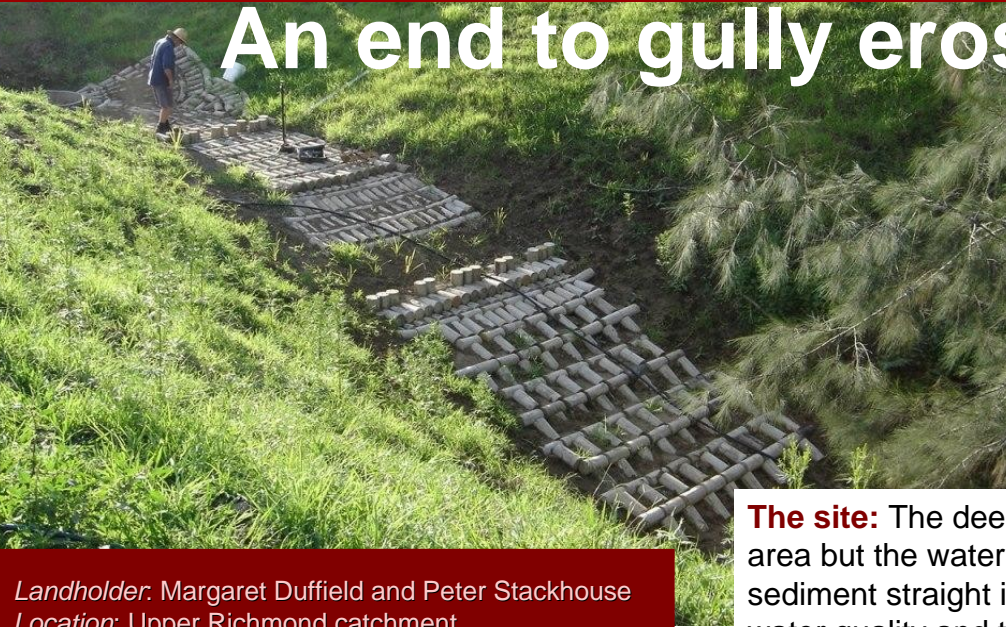
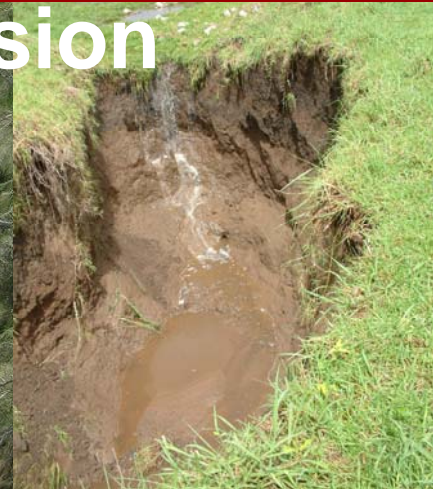
**The site:** The deep gully was less than 1ha in area but the water flowing through it dumped sediment straight into Ironpot Creek, reducing water quality and threatening aquatic life. A constantly wet track at the gully head encouraged further erosion and threatened productive cropping paddocks.

- A large concrete pipe was installed to deliver water from a collection sump behind the gully head to a concrete-lined 'stilling basin' on the bottom of the fully floor.
- The area around the stilling basin was lined with concrete cores to secure

and roughen the surface to reduce the speed of the water flowing from the basin. Groundcovers will grow between the cores and further stabilise the soil.

- The sides of the gully were reshaped and planted with trees to halt further erosion.
- The area was fenced to exclude stock.

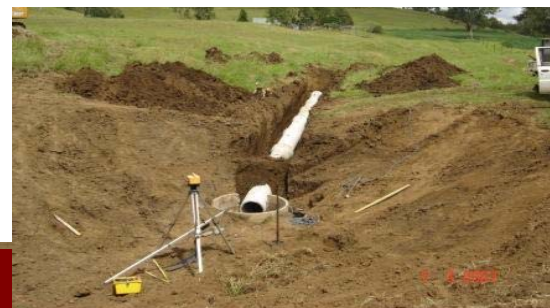
- The collection sump and stilling basin have reduced the erosive potential of the water above the gully.
- Water turbulence is restricted to the concrete-lined gully floor.
- Sediment is no longer deposited in the creek.
