# Soil Erosion Solutions

## Reducing risks in blueberries

**The Site:** The ex banana block on a steep site with poor soil and surrounded by residential development was being prepared for new planting of blueberries.

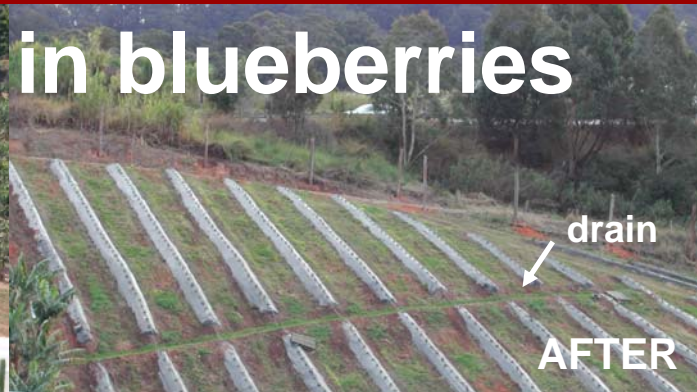
**AFTER**

drain

- Minimise soil loss from a steep horticultural site by integrating soil conservation measures into the development of a new blueberry block.
- Surface drainage and cross-slope graded banks installed to reduce slope lengths and the water flow speeds. A sediment basin was built. Groundcovers were sown to cover all bare soil.

- The long steep slope is now divided in two.
- Excess runoff is directed to safe disposal areas.
- Any sediment lost from the slope is caught in the sediment basin and does not leave the farm.
- Water use efficiency will be greater as water does not accumulate at the base of the slope.
